Model: 250-HMI(S)-450	Jan. 25, 2022
Serial #: N/A	
Product Bulletin # TDS-236 Rev 2

HMI Top Drive Adjustable Extend Arm Upgrade

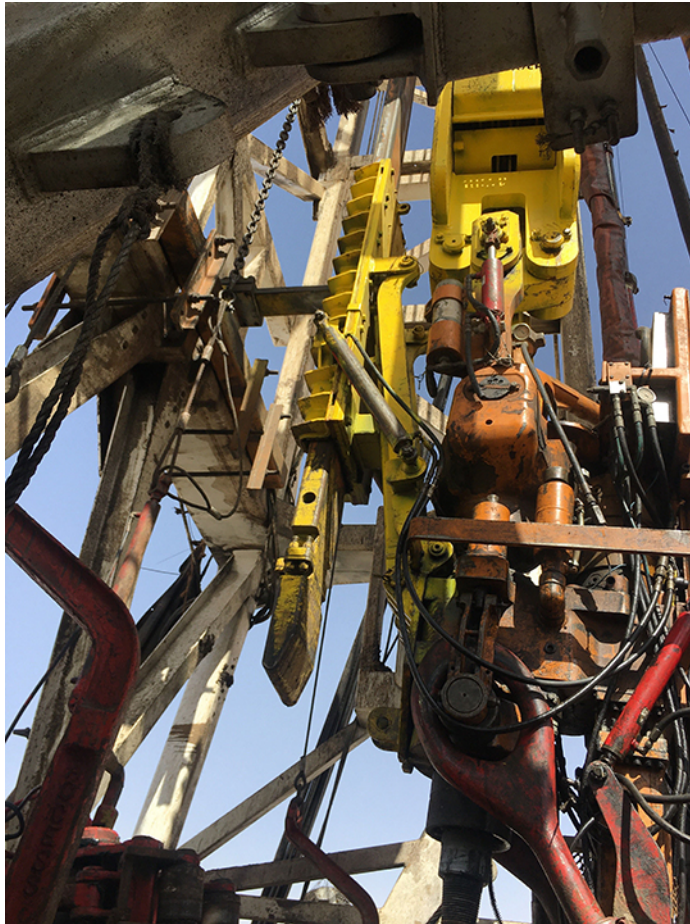
Canrig has requirements for the allowable misalignment of the top drive from the drill stump. (See Product Bulletin TDS-194). Failure to conform to these requirements will result in substantial side loading of the quill. In some cases, this has resulted in the cracking of the quill pin, and/or the Mud Saver Valve (Lower Well Control Valve), causing major equipment failures and safety hazards.

Figure 1: Noticeable Tilt of HMI Top Drive

Inspect your top drive to ensure that it meets the well center alignment criteria shown in Product Bulletin TDS-194.

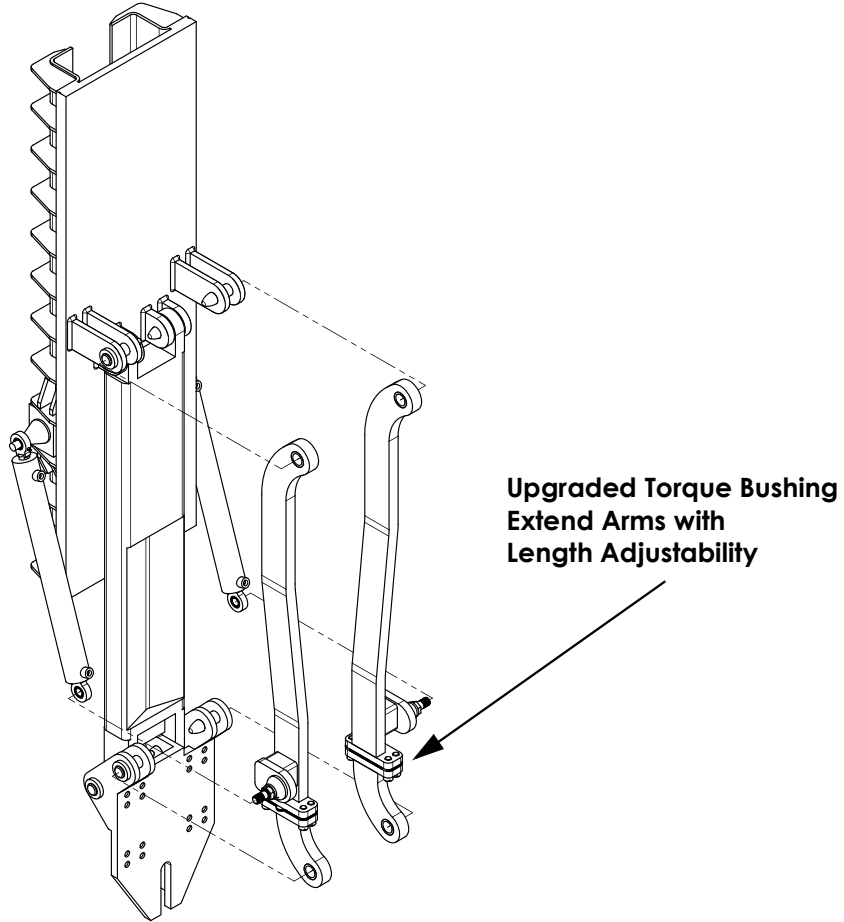
Figure 2: Upgraded Torque Bushing Extend Arms with Length Adjustability

Contact RIGLINE 24/7™ or your Canrig Representative to purchase Upgrade Kit Part # 5102940, to allow tilt adjustability of your top drive. Instructions for proper installation and shimming of upgrade kit will be included with purchase of upgrade kit. (Drawing # 5102940).
