Model: See affected units

Product Bulletin # TDS-244 Rev 2

Tensioning Cylinder Incident

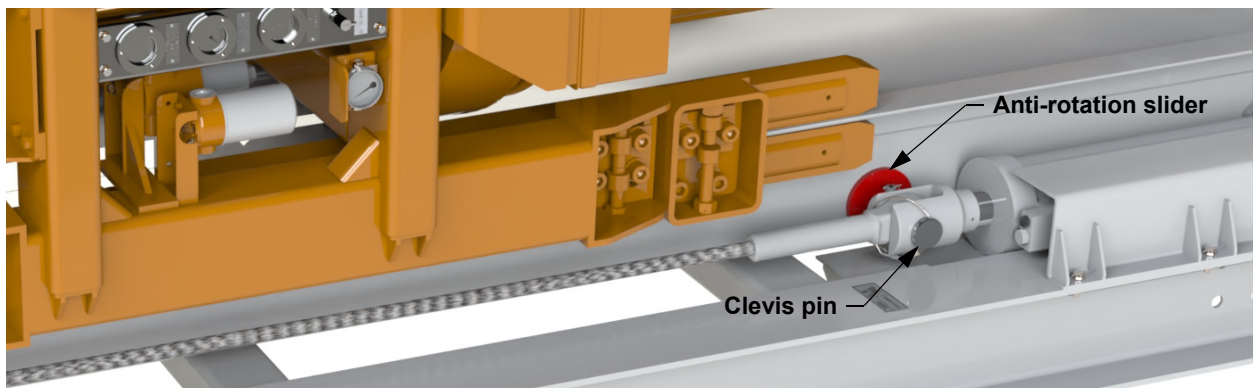
Figure 1: Hydraulic tensioner cylinder

Should the portable torque guide's (PTG) hydraulic tensioner cylinders lose pressure, the PTG cables may become slack, possibly causing the hydraulic cylinders to pivot toward the PTG track and collide with the top drive.

1. Inspect for safety securement of the PTG, including the cylinder clevis pin and anti-rotation slider for securement, as shown in Figure 1.
